Lesion Size Inaccuracies in Digital Mammography

OBJECTIVE. We show with both a clinical case and measurements using the American College of Radiology mammography phantom that some digital mammography acquisition and image display combinations lead to both marked over- and underestimation of lesion sizes on geometrically magnified images.

AJR2010; 194:W115–W118

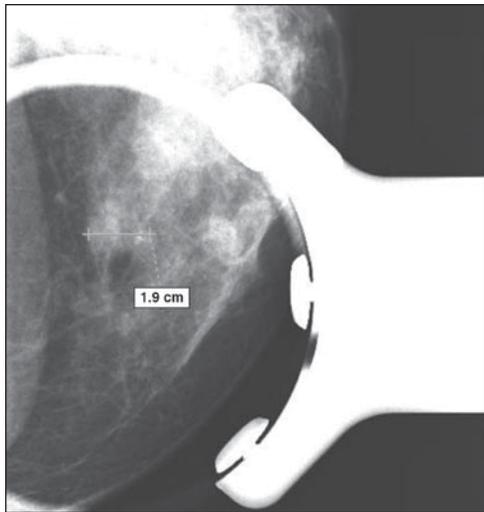
A

Fig. 1—Inaccurate lesion size measurement from magnification mammography in 40-year-old woman. **A**, Geometrically magnified digital image indicates lesion is 1.9 cm. Image was acquired on an Instrumentarium Performa mammography unit (GE Healthcare) with a Fuji CR image receptor (Clearview, Fujifilm USA). Images were displayed and lesion size was measured using Fuji PACS (Synapse, software version 3.2.1).

pression during mammography should not be responsible for the 60–100% error in lesion size found in our clinical example. Greater compression during mammography may explain why the lesion in our clinical example appeared 20–30% larger than it did with other techniques when the proper magnification factor was included ($1.9 \text{ cm} / 1.6 = 1.2 \text{ cm}$, compared with 1.0 cm on breast ultrasound and 0.9 cm on breast MRI) (Fig. 1).

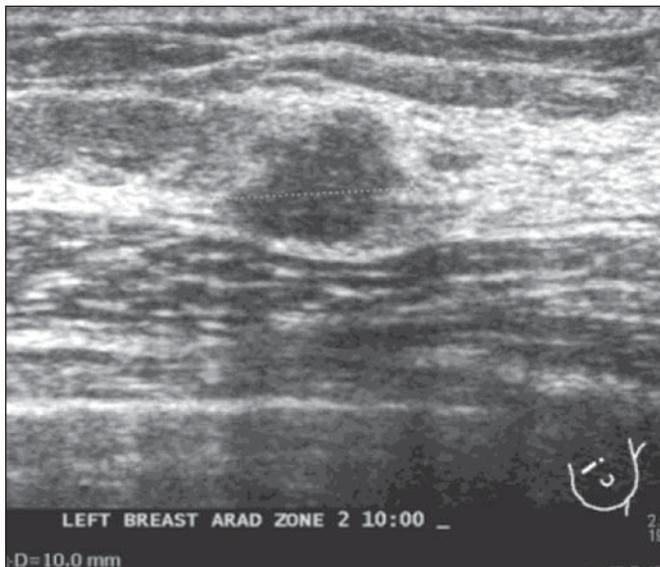
B

B, Ultrasound image of same lesion as that shown in **A** indicates lesion is approximately 1.0 cm.

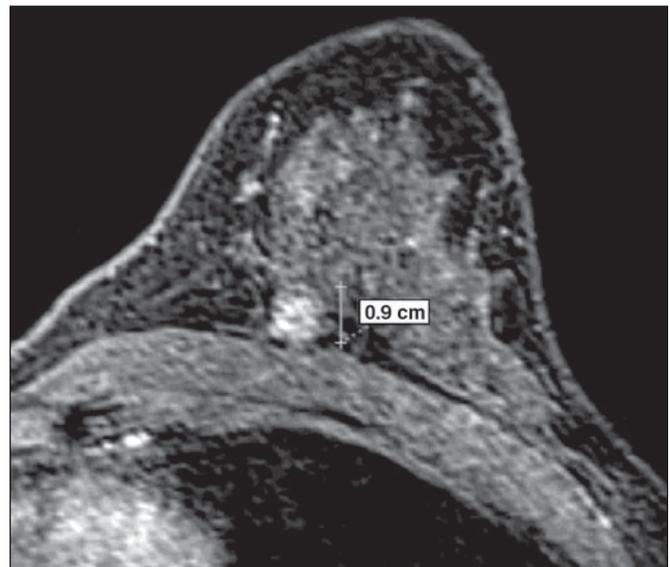
C

C, Cropped contrast-enhanced 3D gradient-echo MR image of same lesion shown in **A** indicates size is approximately 0.9 cm.

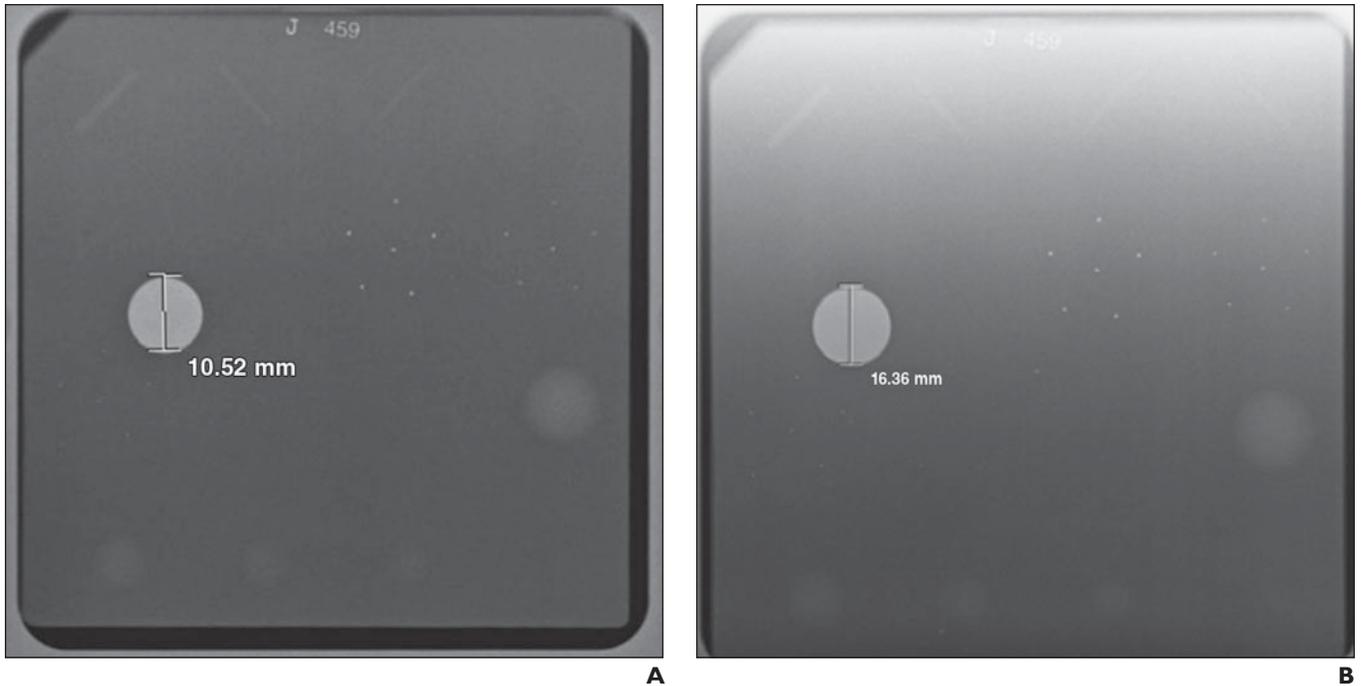
Fig. 2—American College of Radiology phantom with 1-cm acrylic disk was imaged and measured using same acquisition–display system (system X) as in Figure 1. **A**, Diameter of acrylic disk is measured to be 1.05 cm in contact (nonmagnified) image.

B, Acrylic disk is incorrectly measured to be 1.64 cm on 1.6× geometrically magnified image displayed on PACS.

Phantom results for the clinical site with system X, as described earlier, are shown in Figure 2. In contact mode, the 1-cm acrylic disk measured 1.05 cm (Fig. 2A), whereas in 1.6× magnification mode, the 1-cm acrylic disk measured 1.64 cm (Fig. 2B).

In system X, the magnification mode information was not passed from the mammography acquisition system (the same type of acquisition system used for screen-film mammography) to the Fuji CR processor or PACS. Therefore, distances measured on geometrically magnified images were overestimated by a factor approximately equal to the magnification factor (1.6×). This problem occurred even though the CR processor and PACS display were provided by the same manufacturer.

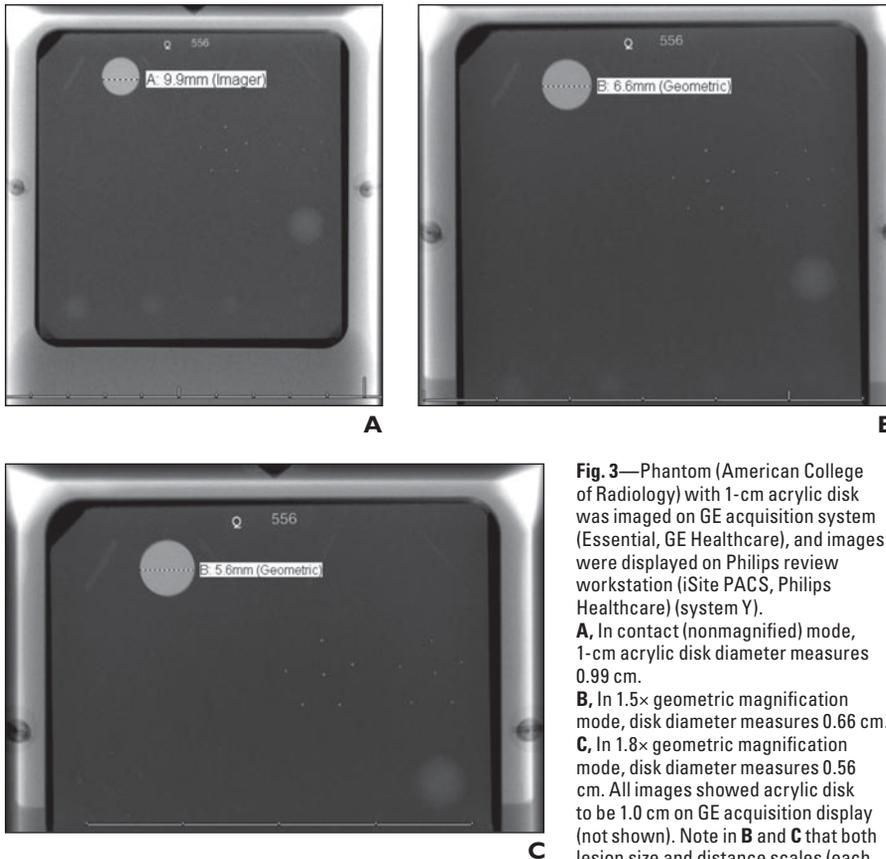
Fig. 3—Phantom (American College of Radiology) with 1-cm acrylic disk was imaged on GE acquisition system (Essential, GE Healthcare), and images were displayed on Philips review workstation (iSite PACS, Philips Healthcare) (system Y).

A, In contact (nonmagnified) mode, 1-cm acrylic disk diameter measures 0.99 cm.

B, In 1.5× geometric magnification mode, disk diameter measures 0.66 cm.

C, In 1.8× geometric magnification mode, disk diameter measures 0.56 cm. All images showed acrylic disk to be 1.0 cm on GE acquisition display (not shown). Note in **B** and **C** that both lesion size and distance scales (each scale step is supposed to be 1 cm) are incorrectly displayed on PACS.

tem (Senographe Essential, GE Healthcare) and different PACS (iSite [software version 3.6.51], Philips Healthcare), which we refer to as “system Y,” are shown in Figure 3. The 1-cm acrylic disk was measured as 0.99 cm in contact mode (Fig. 3A), 0.66 cm in 1.5× magnification mode (Fig. 3B), and 0.56 cm in 1.8× magnification mode (Fig. 3C).

In system Y, magnification factors were passed from the digital acquisition system to the PACS display system. As a result of software incompatibilities, however, the magnification factor was accounted for twice (once by each system), thus registering a smaller lesion size for higher magnification factors.
